Stair Safety: Causes and Prevention of Residential Stair Injuries

Housing Fact Sheets

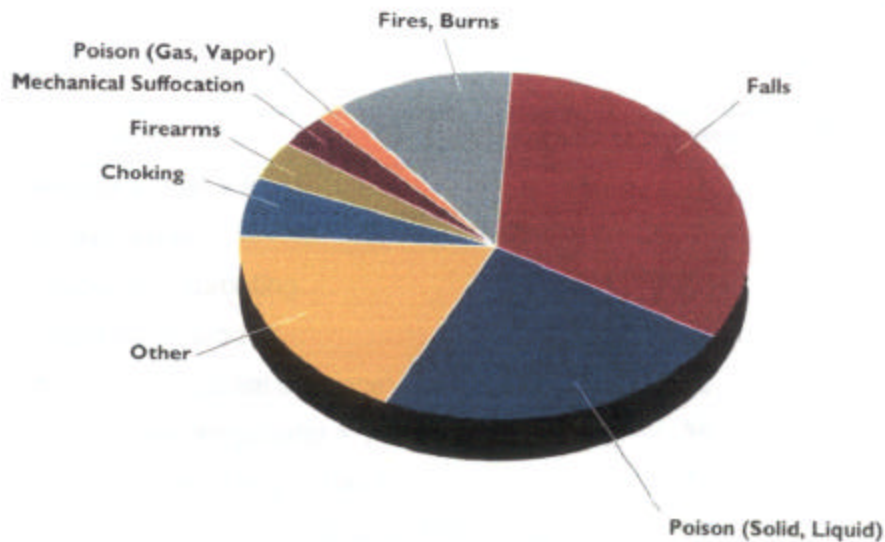
Pie Graph Illustration from *Accident Facts* (1998)

In the United States during 1997 about 27,000 people were killed by unintentional home injuries.¹ Figure 1 illustrates the causes of some of the injuries that resulted in death. As you can see, falls account for the majority of incidents.
